Thank you for the opportunity to provide you with this Consultation Inspection as you consider the purchase of 123 A Street, NE in Washington, DC. Below is a bulleted list of the items I noted or we spoke about regarding the current conditions of the home.

Photo Plates

123 A Street, NE

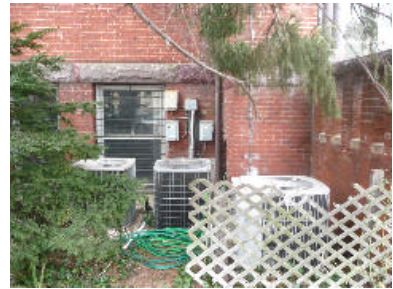
Photo #2

- AC unit #4 was in 1988, this system cools the second floor, the thermostat is located on the second level. This system was operational. However, it has passed its useful life and you should budget to replace it. There was a repaired leak under the air handler in the ceiling of the front left second floor landing. The air handler is located in the attic space above this landing. When replacing the system, you should consider installing the air handler in a more convenient location.

- The Furnace for the second floor was also installed in 1988, this system was operational, however the HVAC for the second floor should be replaced, as the system is passed its useful life.

AC unit #4 was in 1988, this system cools the second floor, the thermostat is located on the second level. This system was operational. However, it has passed its useful life and you should budget to replace it. There was a repaired leak under the air handler in the ceiling of the front left second floor landing. The air handler is located in the attic space above this landing. When replacing the system, you should consider installing the air handler and compressor in a more convenient location

The Furnace for the second floor was also installed in 1988, this system was operational, however the HVAC system for the second floor should be replaced, as the system is passed its useful life.

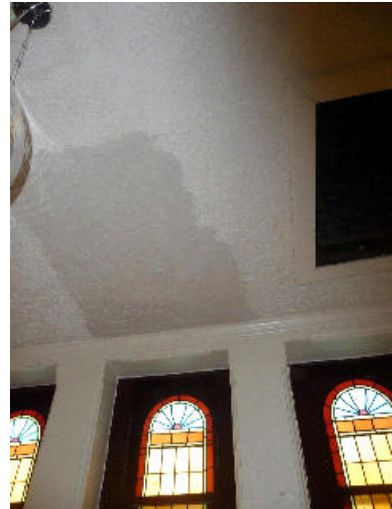
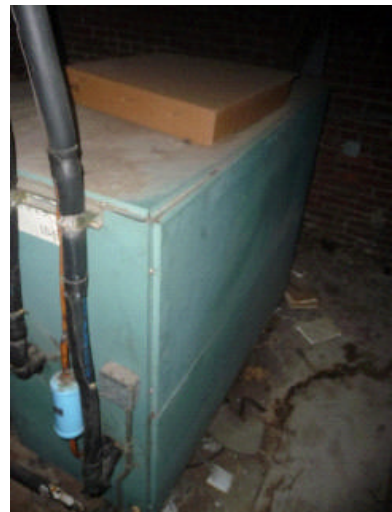
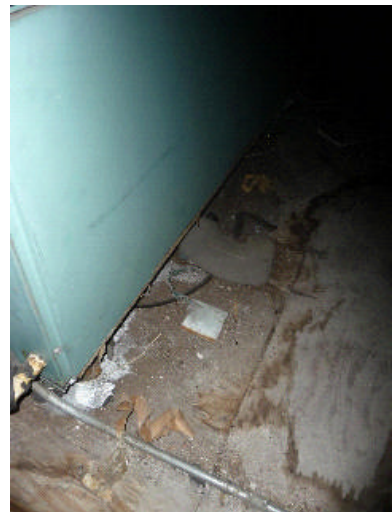
Photo #3

There are 3 new high efficiency furnaces which were installed 2010, the furnaces are located in the basement and service the basement and first floor levels. These systems have a life expectancy of 18-20 years. All three were operational.

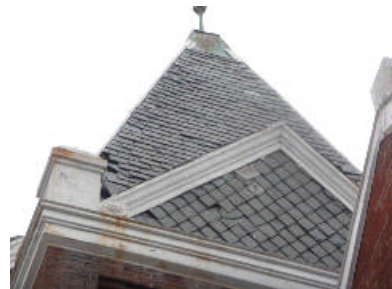
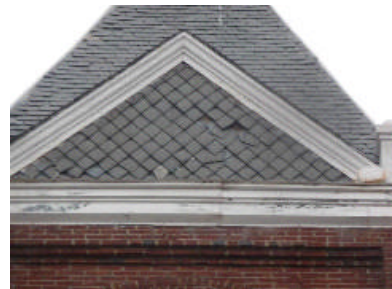
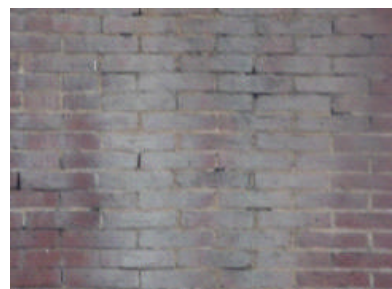
Photo #5

- The exterior trim needs to be scraped and painted
- The brick siding needs repair, extensive re-pointing is required. There was a stop work order notice on the front door for re-pointing or brick work without a permit. The notice was issued on 9/20/10.

The brick siding needs repair, extensive re-pointing is required. There was a stop work order notice on the front door for re-pointing or brick work without a permit. The notice was issued on 9/20/10. Further evaluation and repair from a qualified mason is required.
