## mid-atlantic inspection services

At your request we have performed an inspection of the property at Street Address in Washington, DC on February 9, 2011.

# PROPERTY INSPECTION REPORT SUMMARY

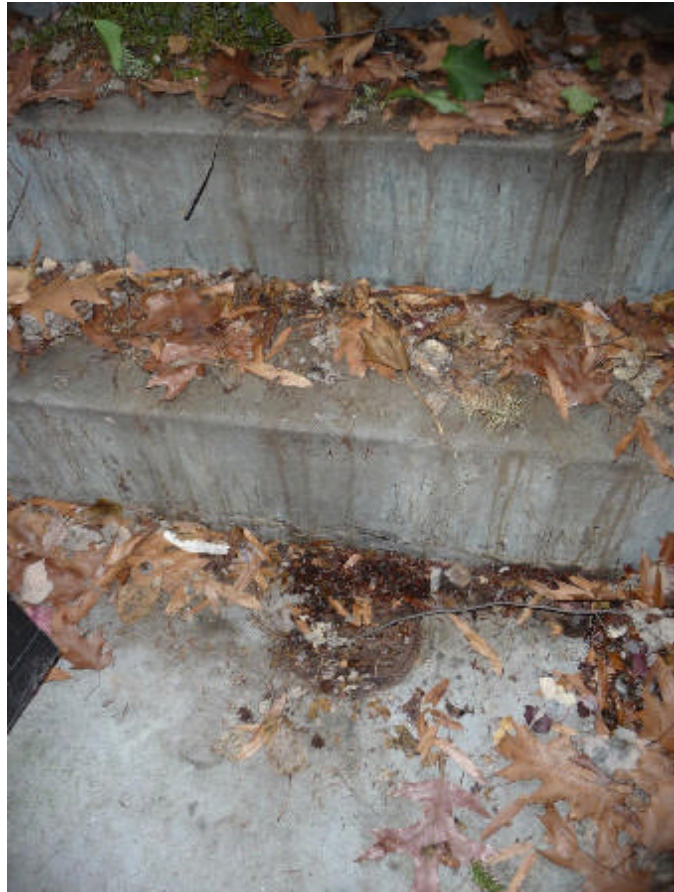
Monitor: The basement walkout floor drain should be kept clear at all times to prevent flooding.

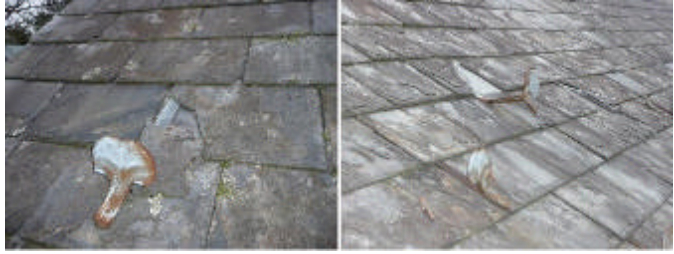
Slate. Slate roofing materials are very durable; however they do require periodic maintenance. The roof should be evaluated by qualified roofing contractor every 1-2 years.

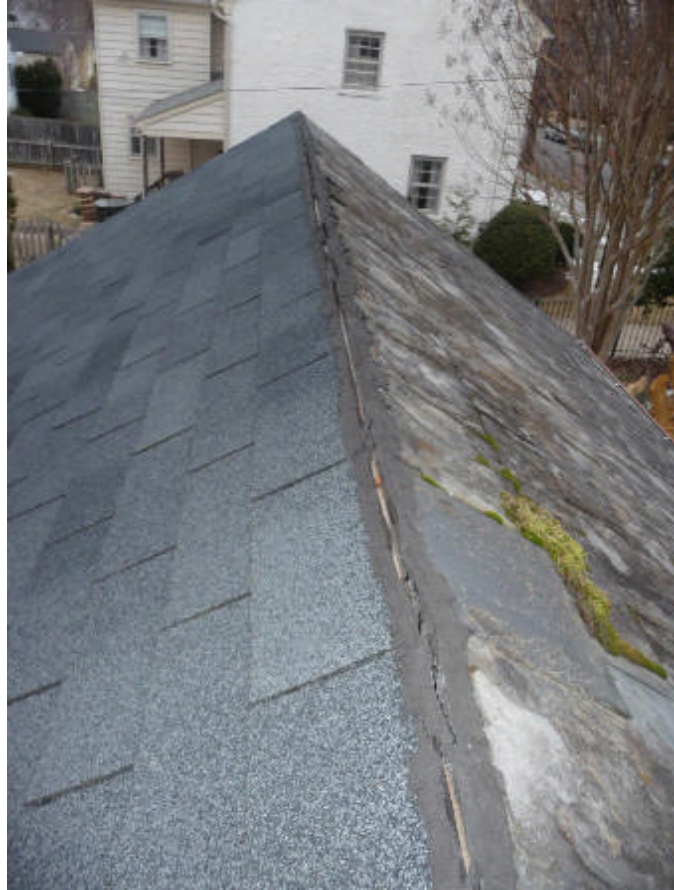
Replace: The slate roof ridge caulking at the garage is dry and deteriorated. The ridge caulking needs replacement.

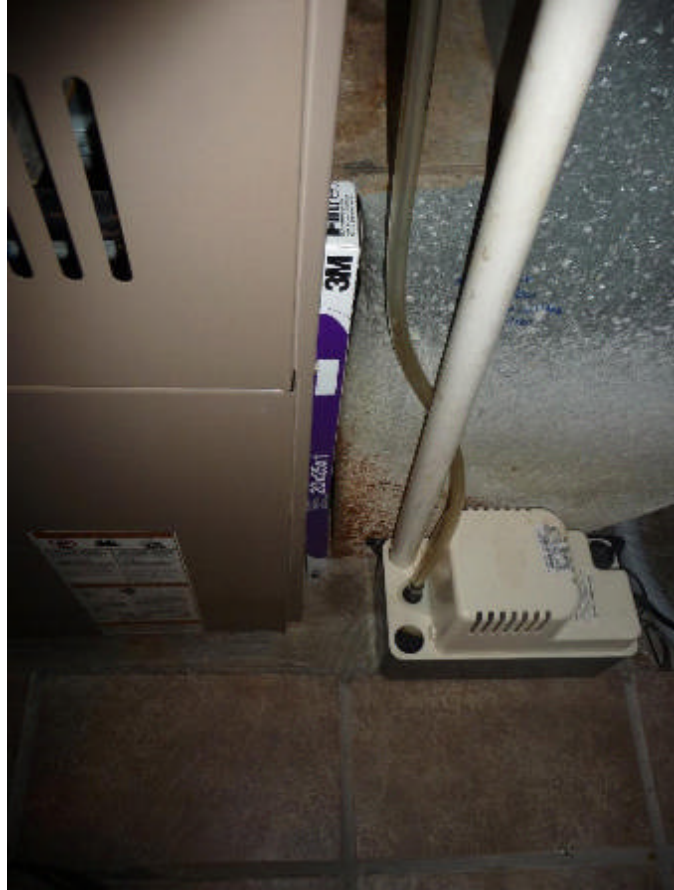
A 2025x1 inch filter is installed at the right side of the air handler.

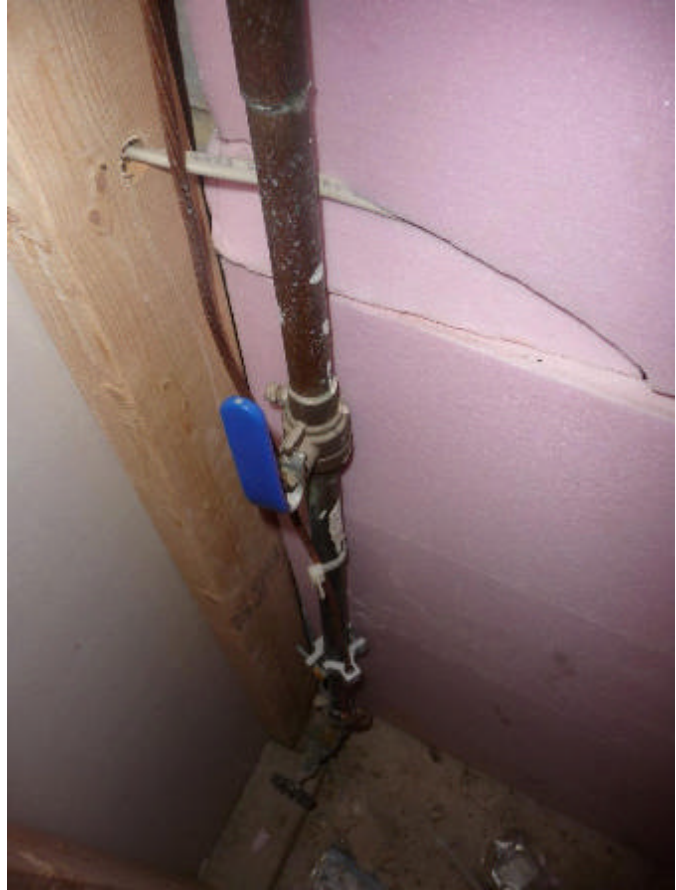
Basement level, front wall.

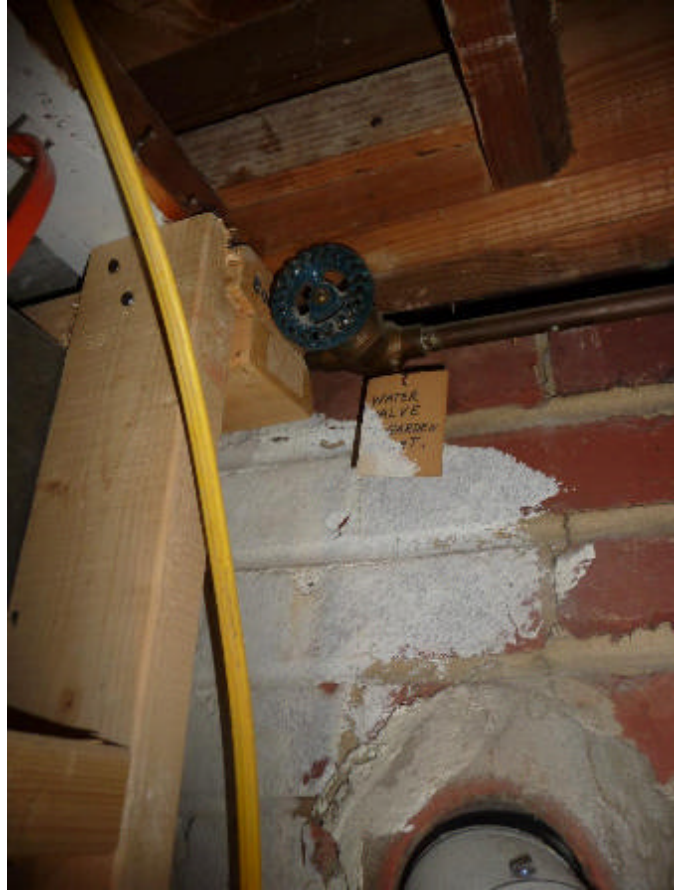
The winter shutoff valves for the exterior hose bib(s) are located above the water heater. An additional exterior hose connection at the left side of the front door but the winter shut off was not located. You should ask the seller about the location of this valve.

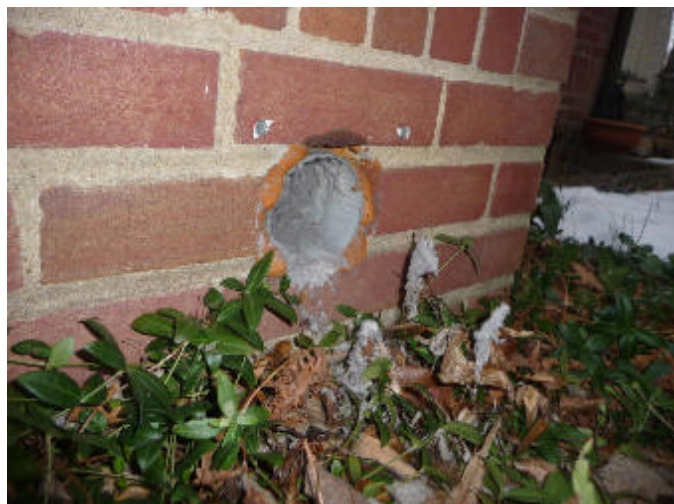
The dryer vent termination is missing at the rear wall and should be replaced.

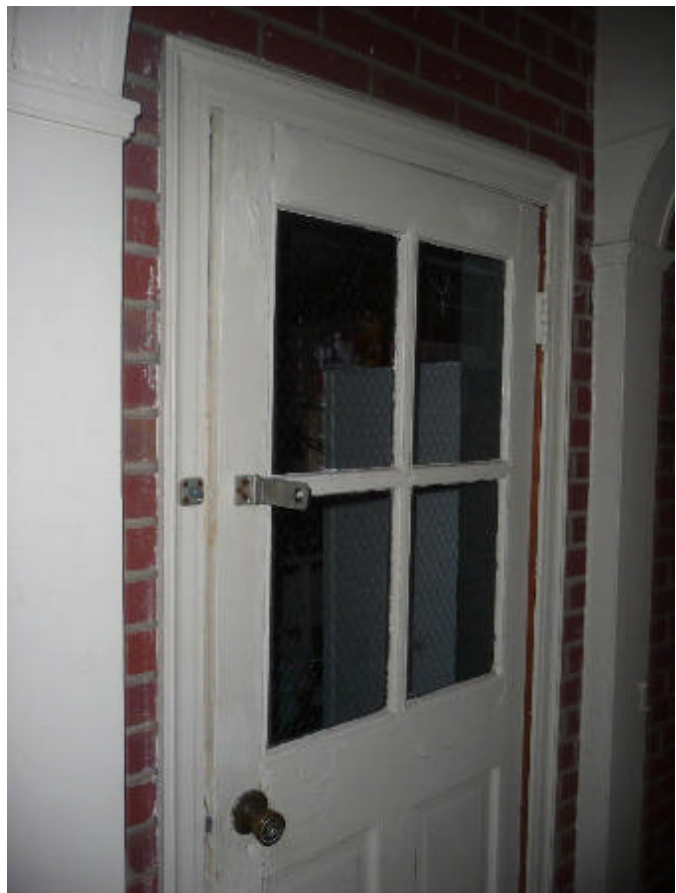
The passage door from the breezeway does not close.
