Thank you for the opportunity to provide you with this Consultation Inspection as you consider the purchase of 123 A Street, NE in Washington, DC. Below is a bulleted list of the items I noted or we spoke about regarding the current conditions of the home.

Photo Plates

123 A Street, NE

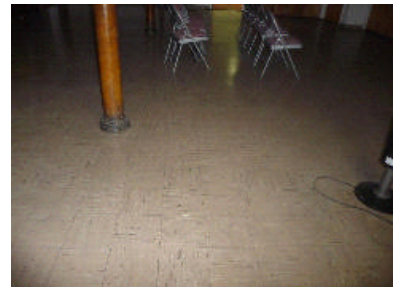
Photo #16

The basement flooring appears to be an asbestos tile. Asbestos materials are manufactured of mineral fiber and are long lasting. Asbestos tiles are not generally a health hazard while in good condition. At the time of removal these tiles may be considered hazardous, and should be handled in a manner consistent with E.P.A. guidelines.
